AIRBAG INVESTIGATION

CASE NO. 93-05

TECHNICAL REPORT

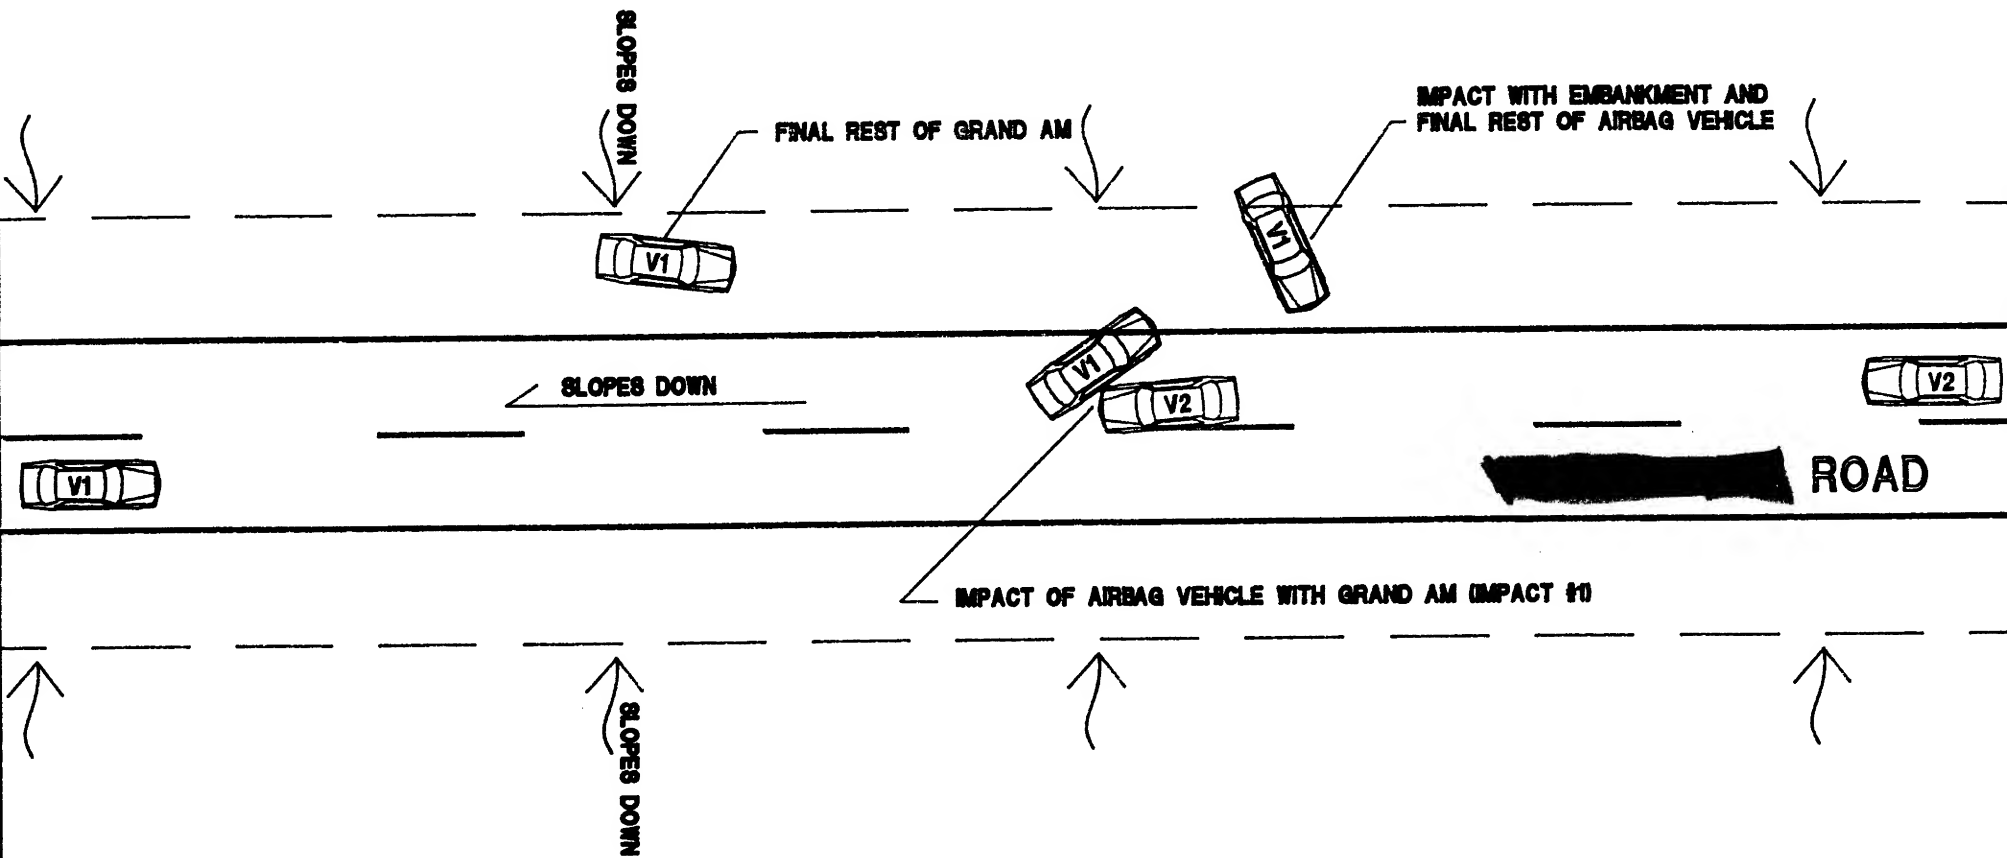
LEGEND OF SYMBOLS	
V1 - AIRBAG VEHICLE (1991 MERCURY CAPRI)	
V2 - OTHER VEHICLE (1986 PONTIAC GRAND AM)	
NATIONAL CAPITOL SYSTEMS, INC.	SCALE: 1" = 20'

NHTSA SOUTH CENTRAL STATES INDEPTH ACCIDENT INVESTIGATION TEAM	CASE NUMBER 83-05
ACCIDENT DATE: [REDACTED] 1992	LOCATION: [REDACTED] ROAD, [REDACTED] COUNTY, GEORGIA

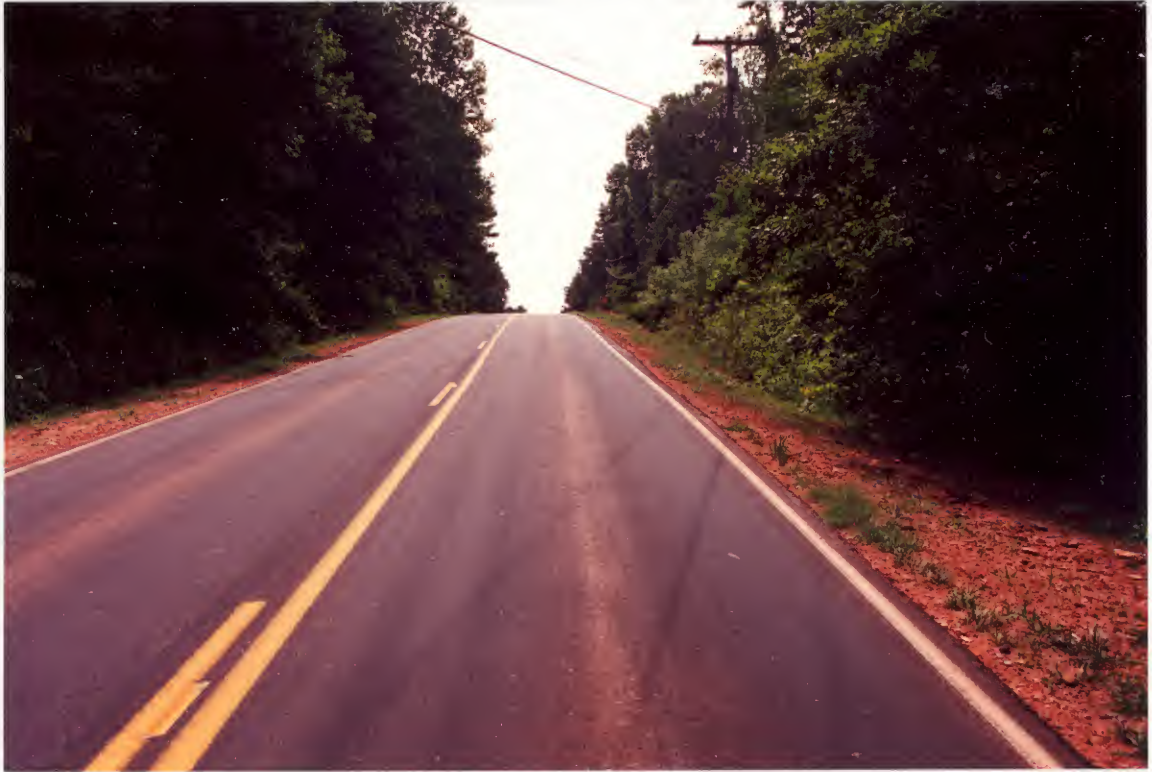
1. Pre-impact travel path of the 1991 Mercury Capri convertible (airbag equipped vehicle) east on Road in Georgia.

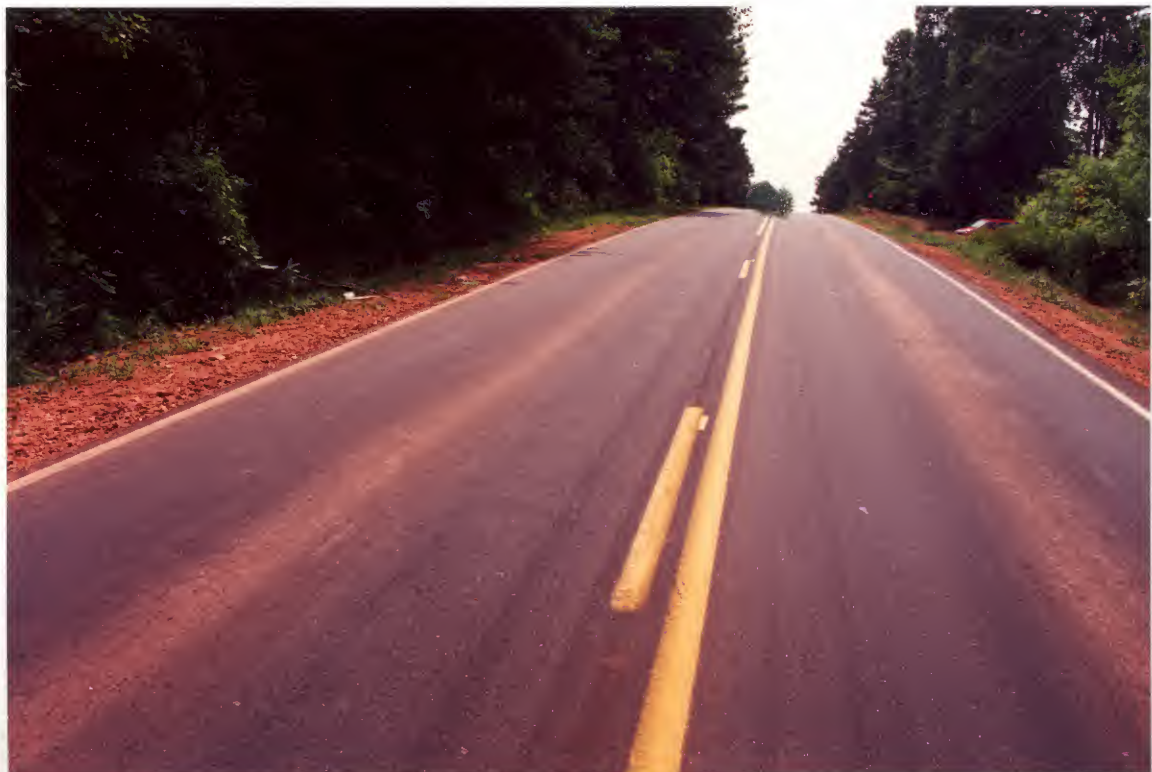
2. Path into impact and area of impact with the 1986 Pontiac Grand Am.

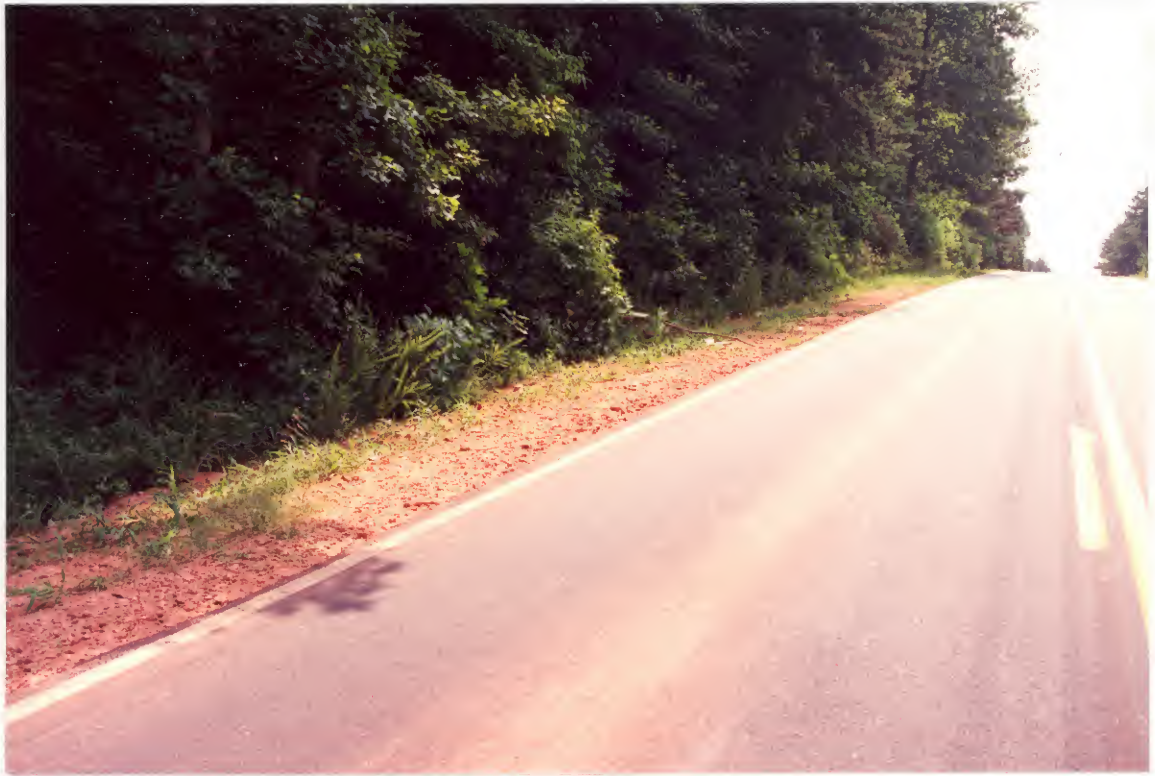
3. Path of Capri from impact with the Grand Am to impact with the road edge embankment and final rest.

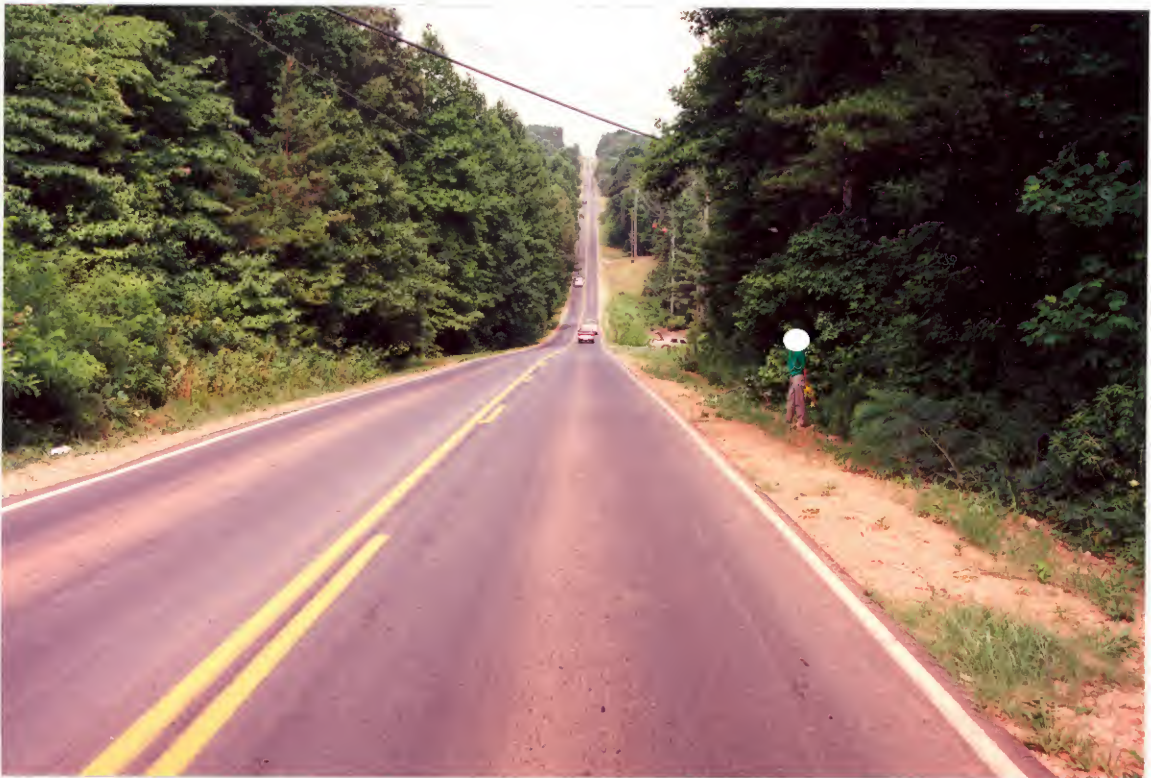
6. Pre-impact travel path of the 1986 Pontiac Grand Am west on Road.

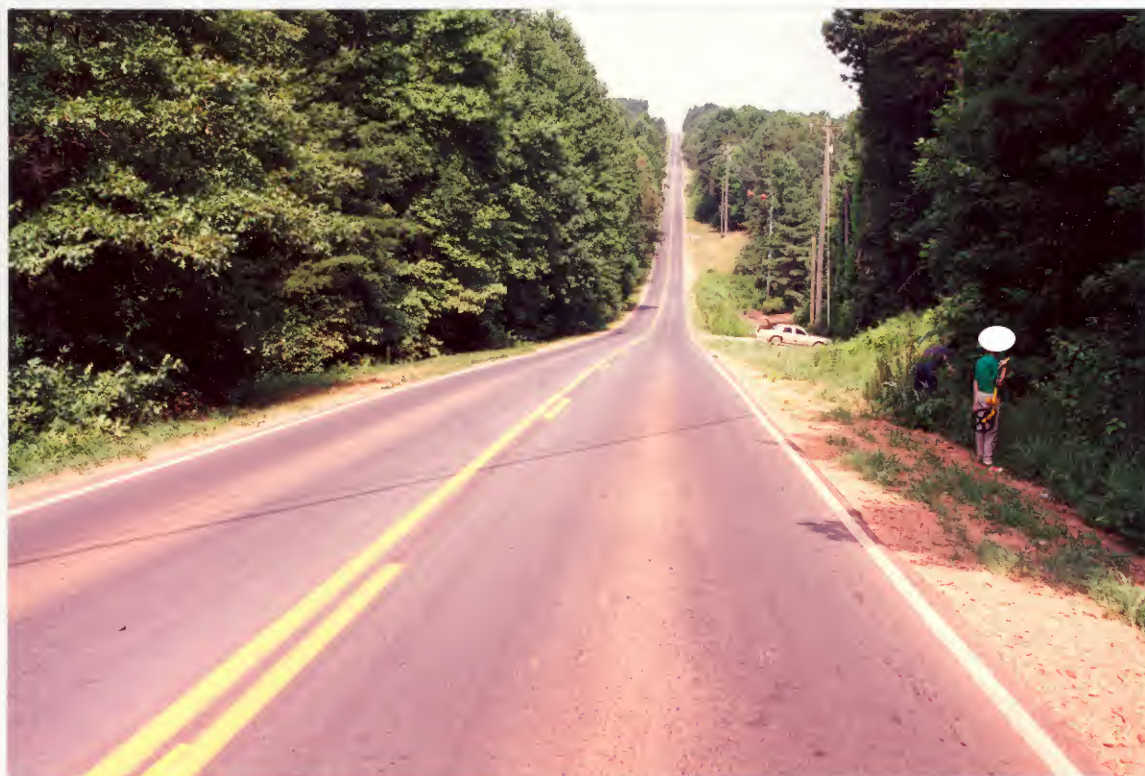
7. Path into impact and area of impact with the Capri.

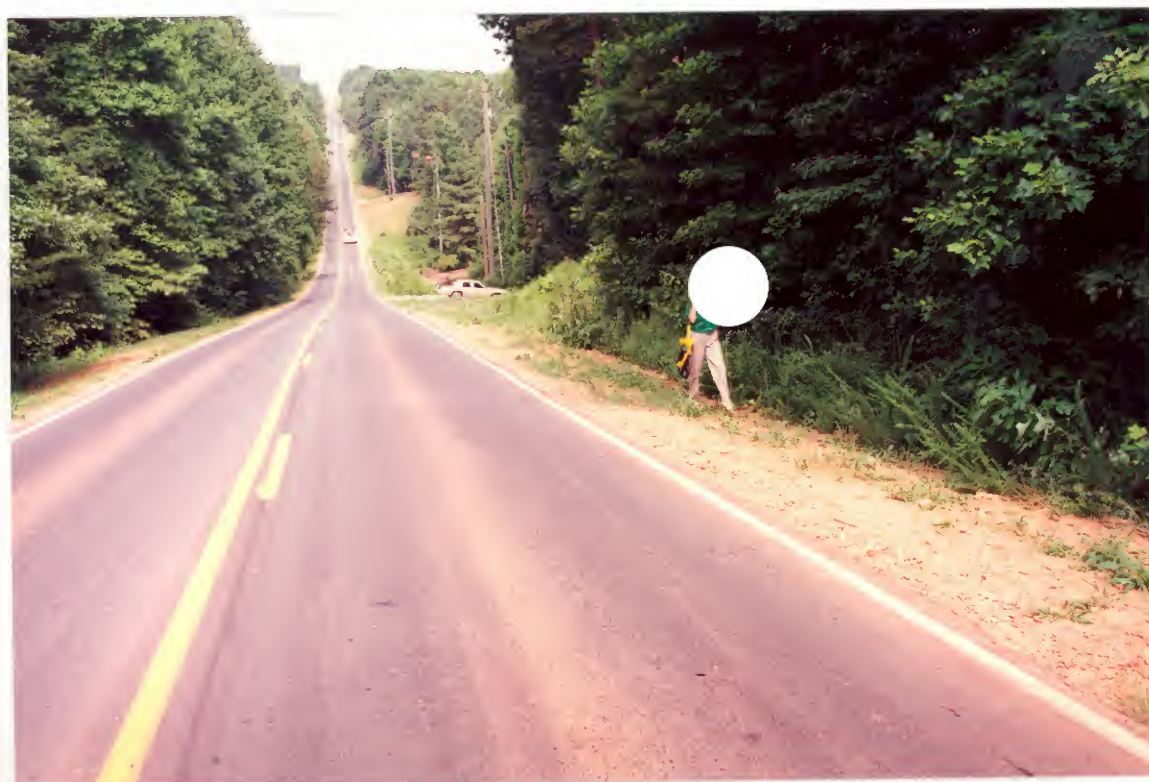
8. Path of the Grand Am from impact to final rest.

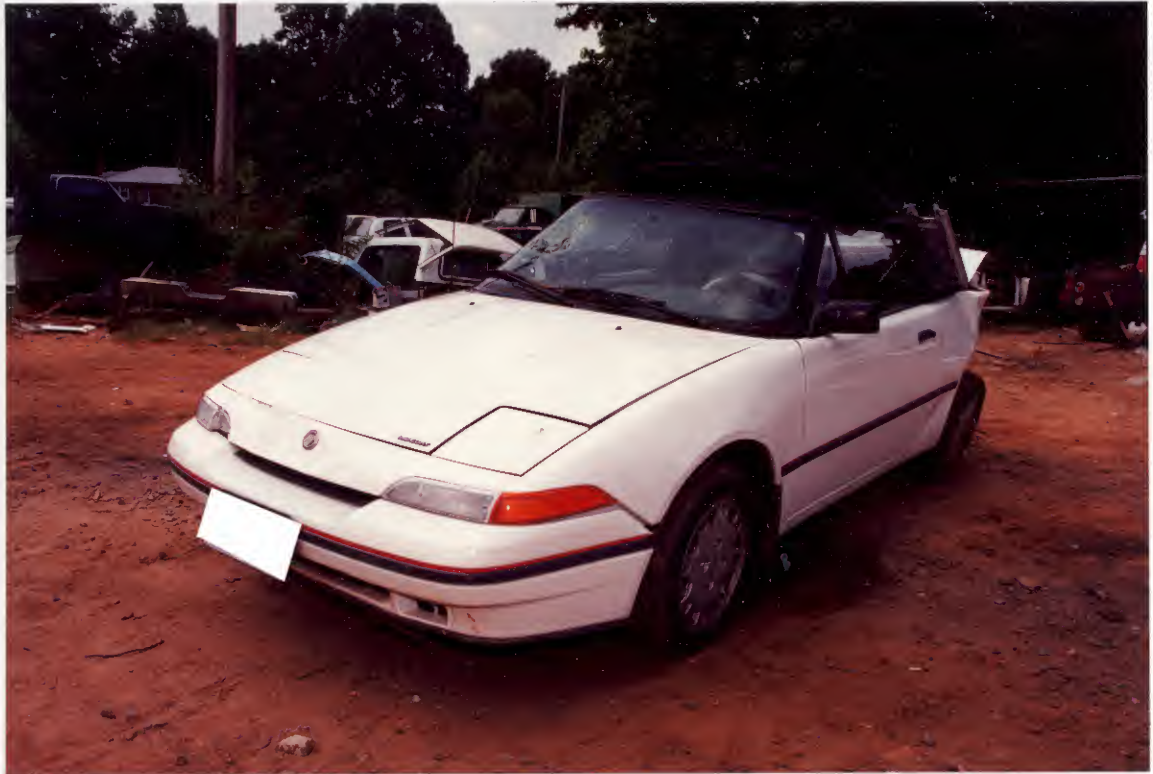
11. Front-left overall view of the 1991 Mercury Capri convertible (airbag vehicle).

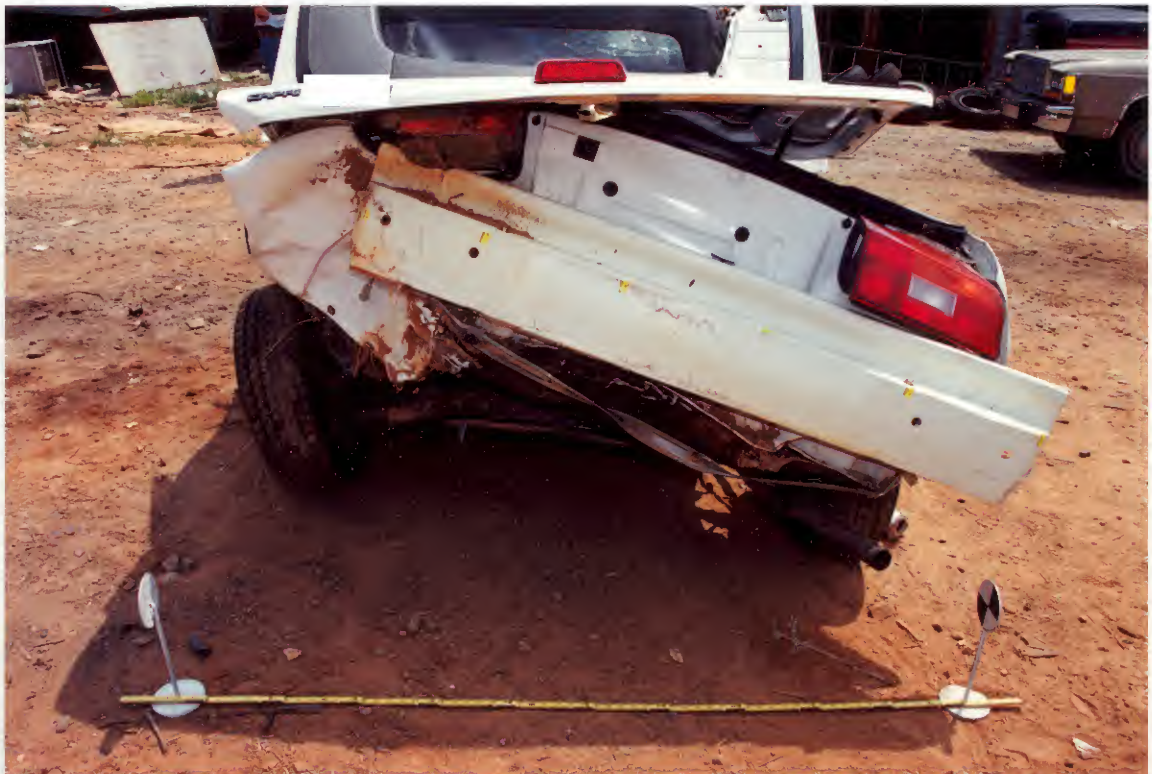
14. Rear view showing damage from impact with the embankment (impact #3).

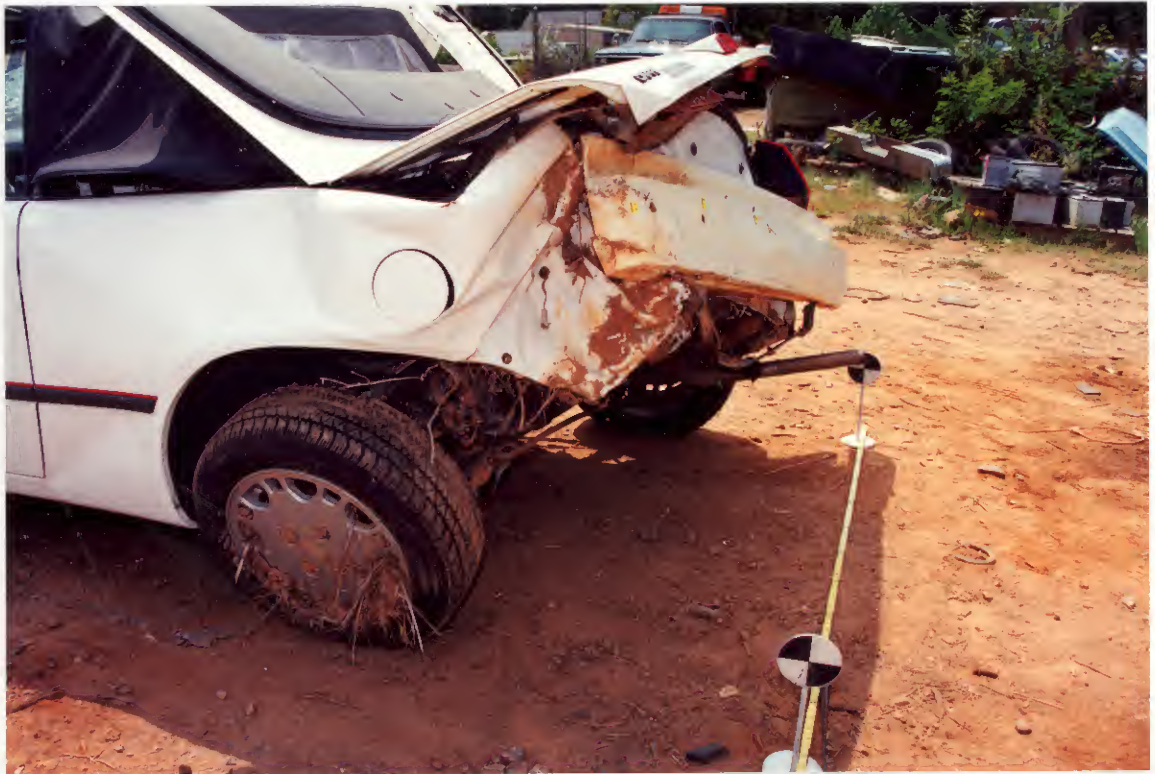
15. Second rear view of damage from impact #3.

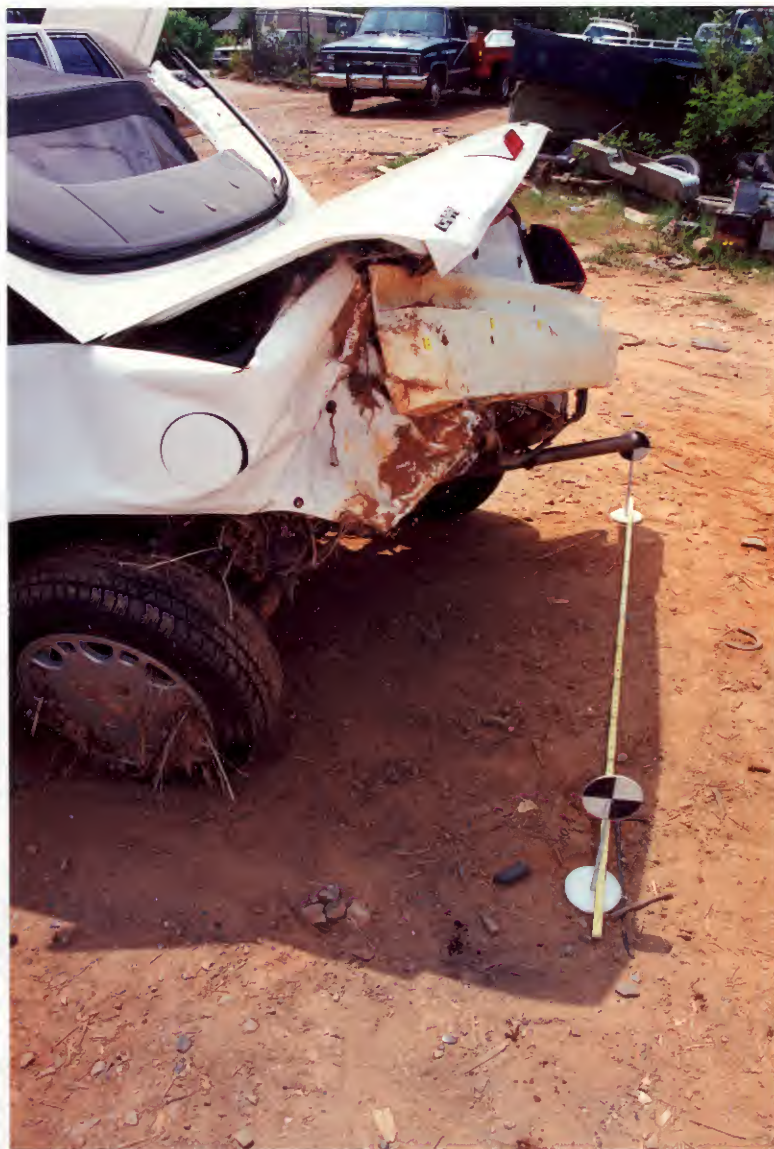
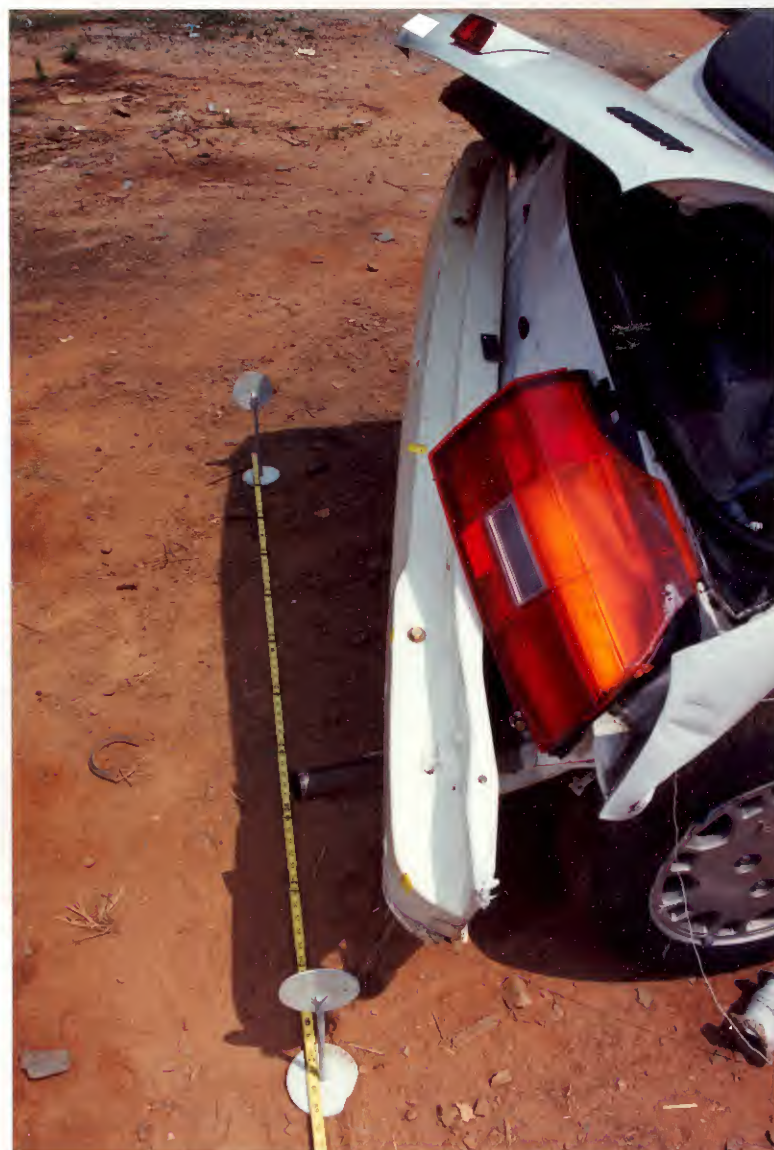
16-17. Views along rear stringline from the left side and right side.

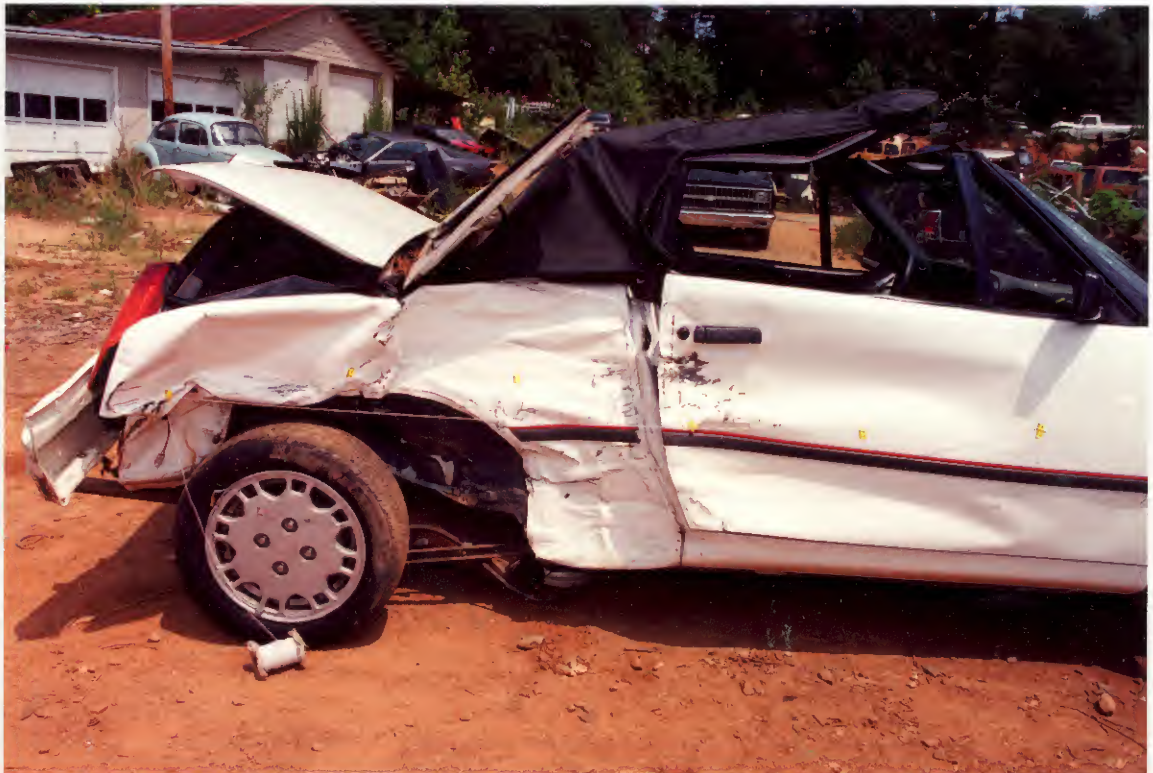
19. Right side view of damage from first impact with the Grand Am.

A CDC of 01-RZEW-2 was assigned to the damage to the airbag-equipped Capri from the initial impact with the Grand Am. Maximum residual crush to the right side of the Capri was approximately 18 centimeters, located a short distance forward of the rear axle. A CRASH 3 reconstruction of the Delta V (speed change) using CDC data only, resulted in an estimated total Delta V of 24 kilometers per hour for the Capri and 22 kilometers per hour for the Grand Am. These should be considered as estimates only, as the Grand Am was not inspected, but CDC's were assigned from photographs.

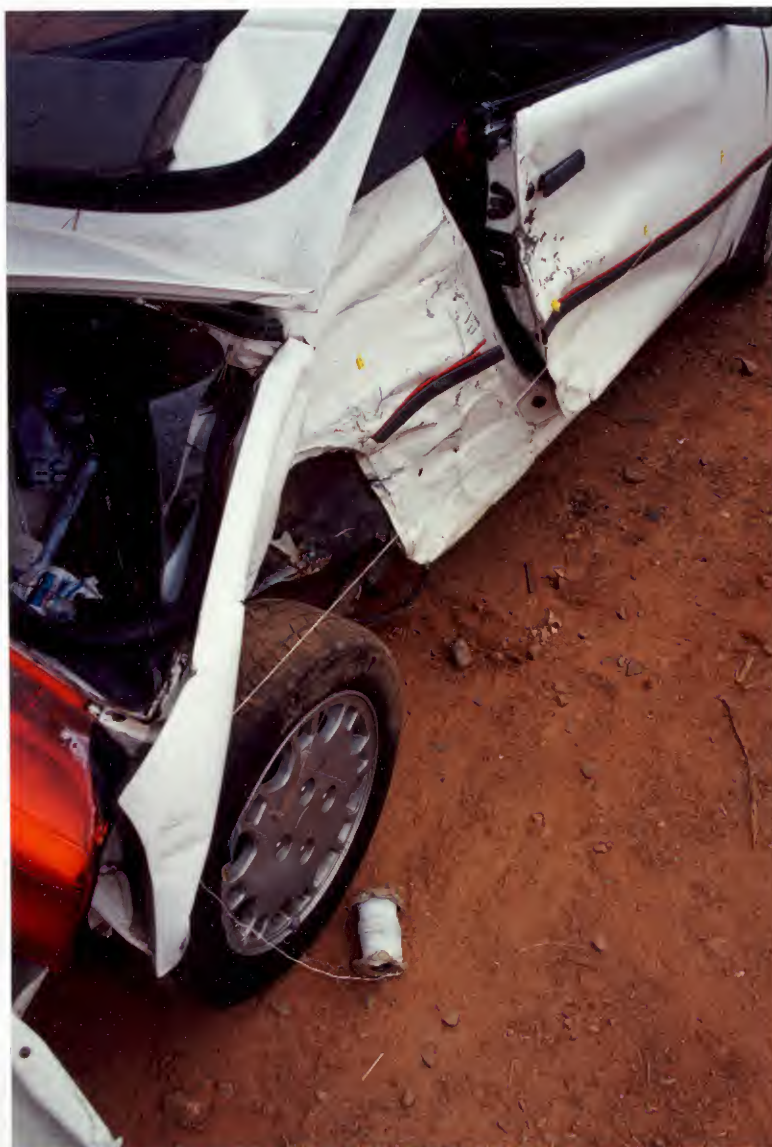
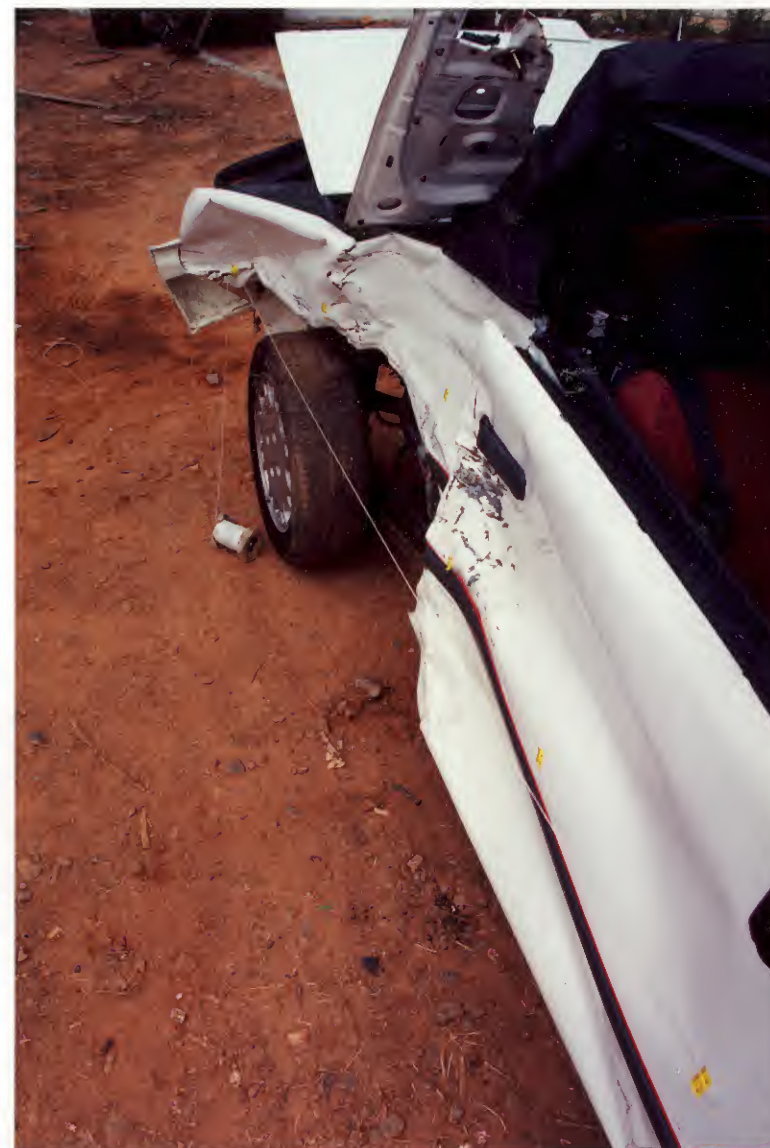
20-21. Views along the right side plane showing crush from the first impact with the Grand  
Am.

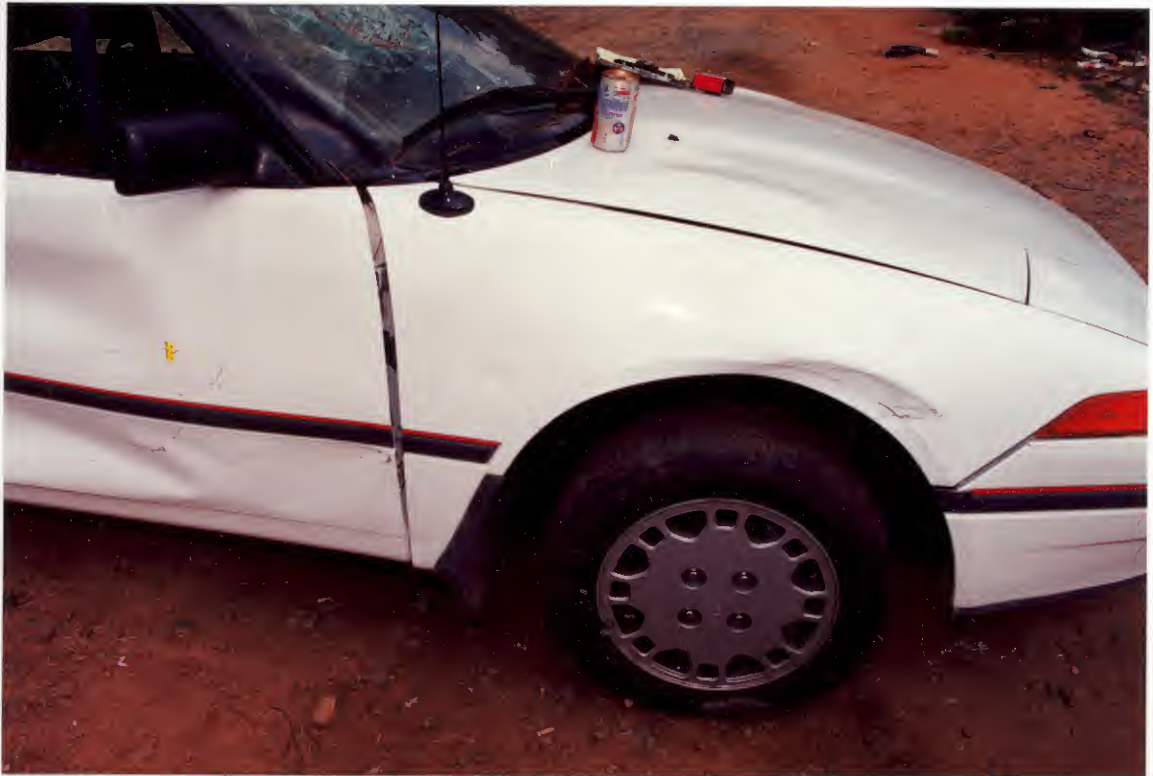
22. Right side view showing damage from the sideslap with the Grand Am (impact #2).

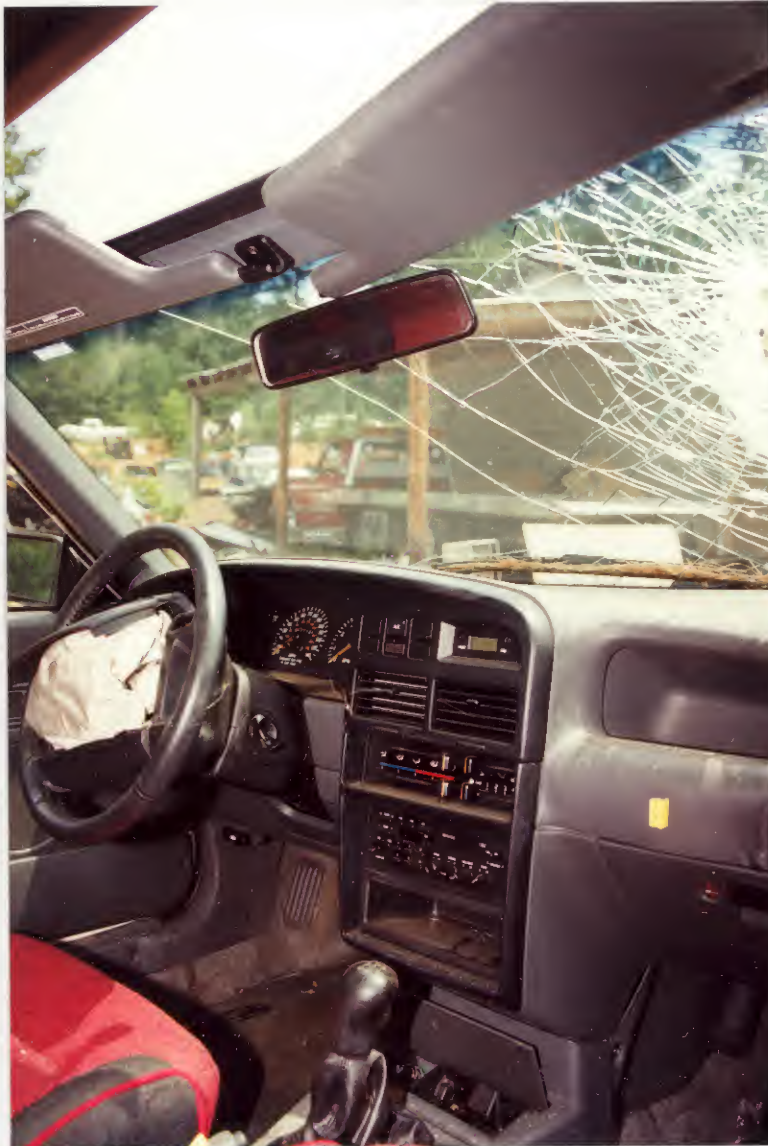
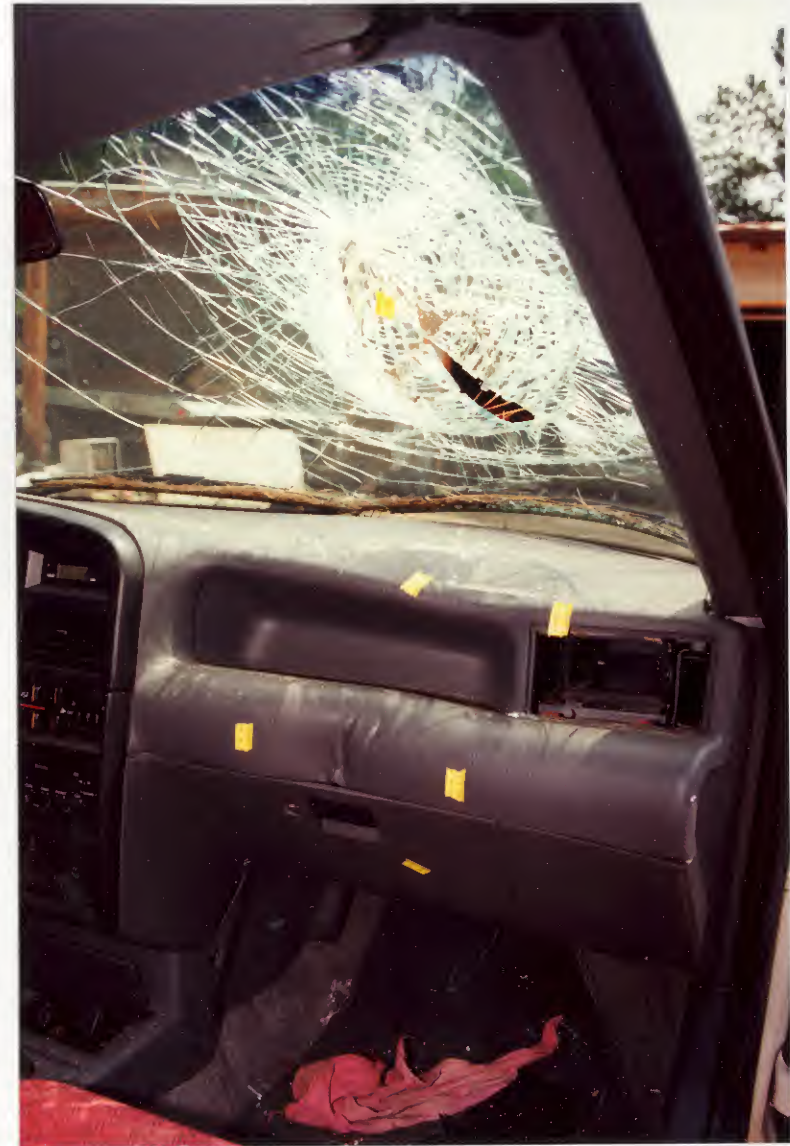
23-24. Interior views showing obvious occupant contacts to windshield and right instrument panel.

Deployed airbag,  
cracked console,  
deformed right side  
instrument panel,  
broken right front  
air-conditioning  
vent, and windshield  
cracked by occupant  
contact.

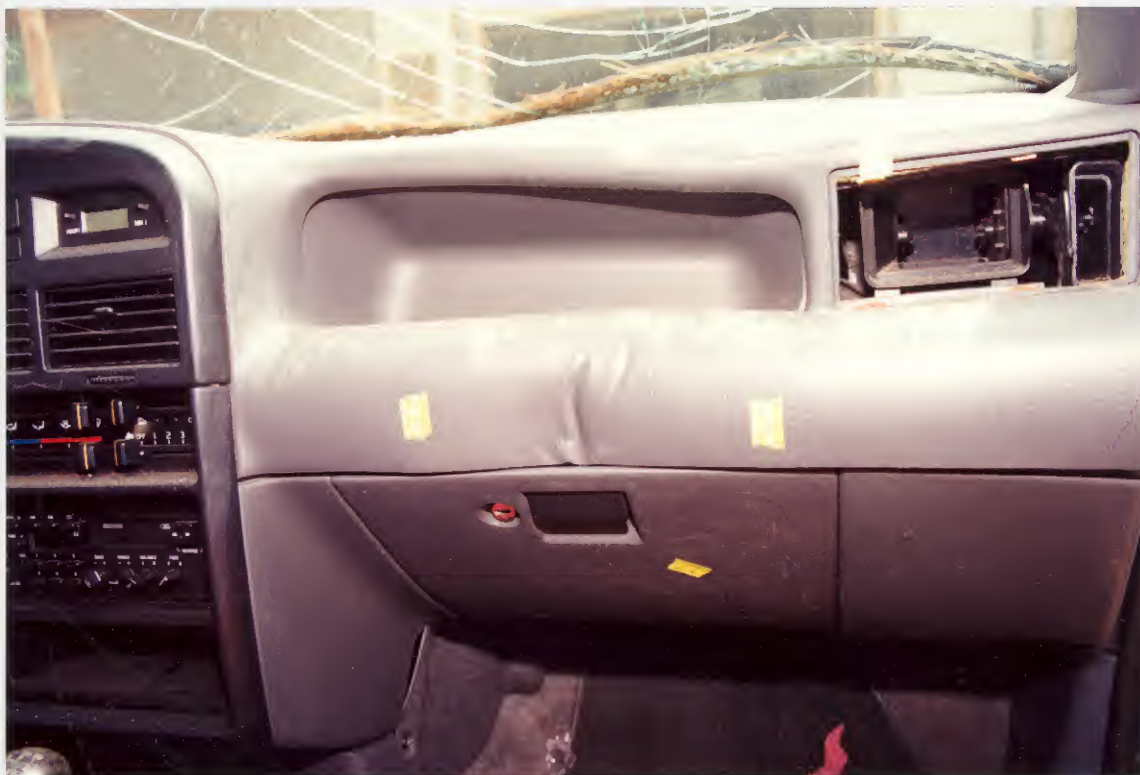
25. Right instrument panel showing obvious occupant contact points.

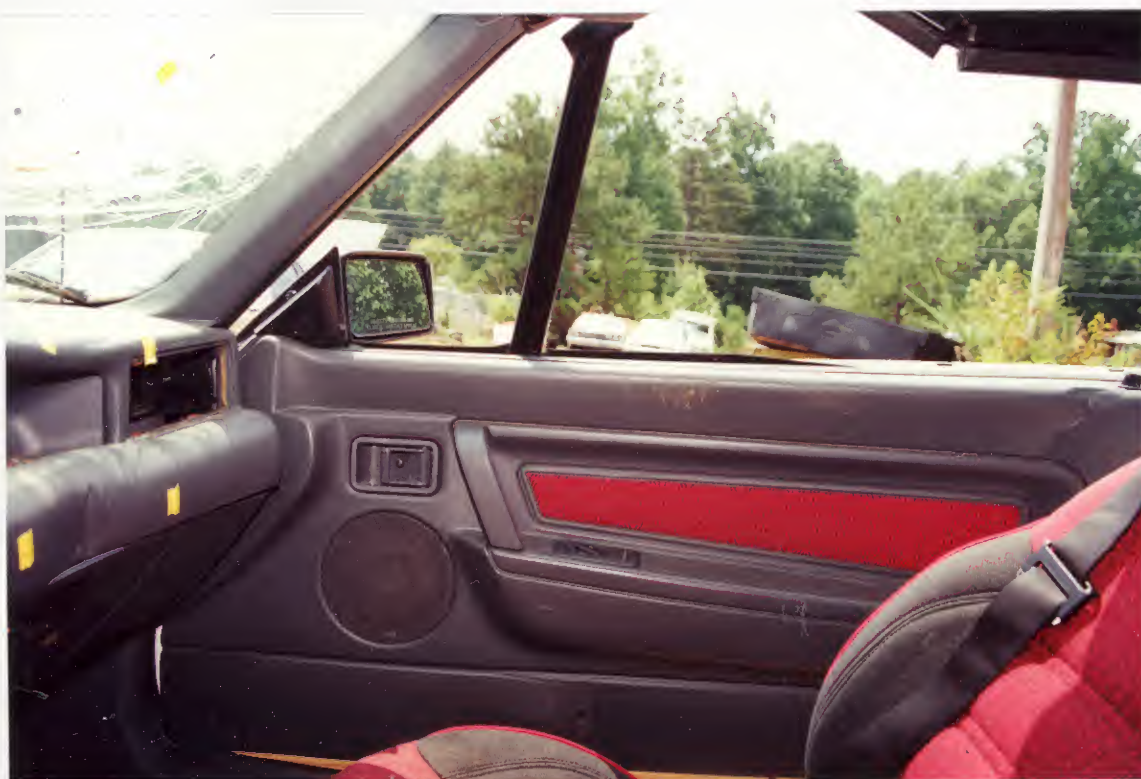
26. View of right instrument panel and right door.

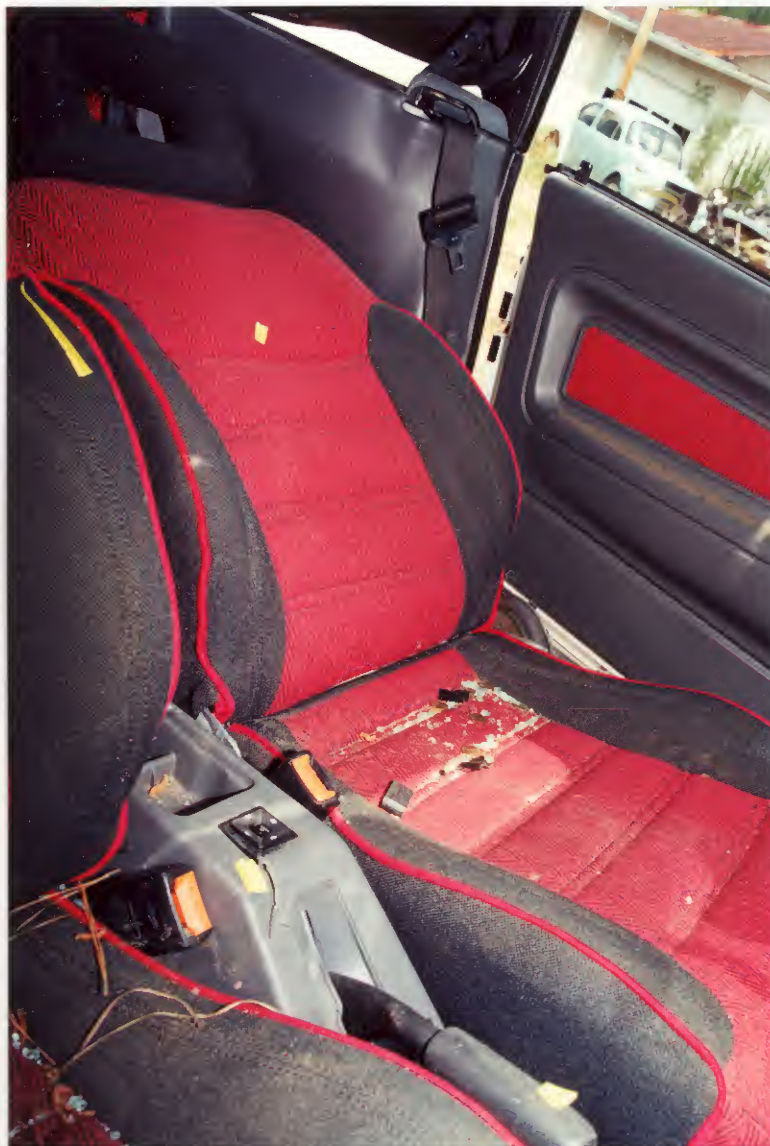
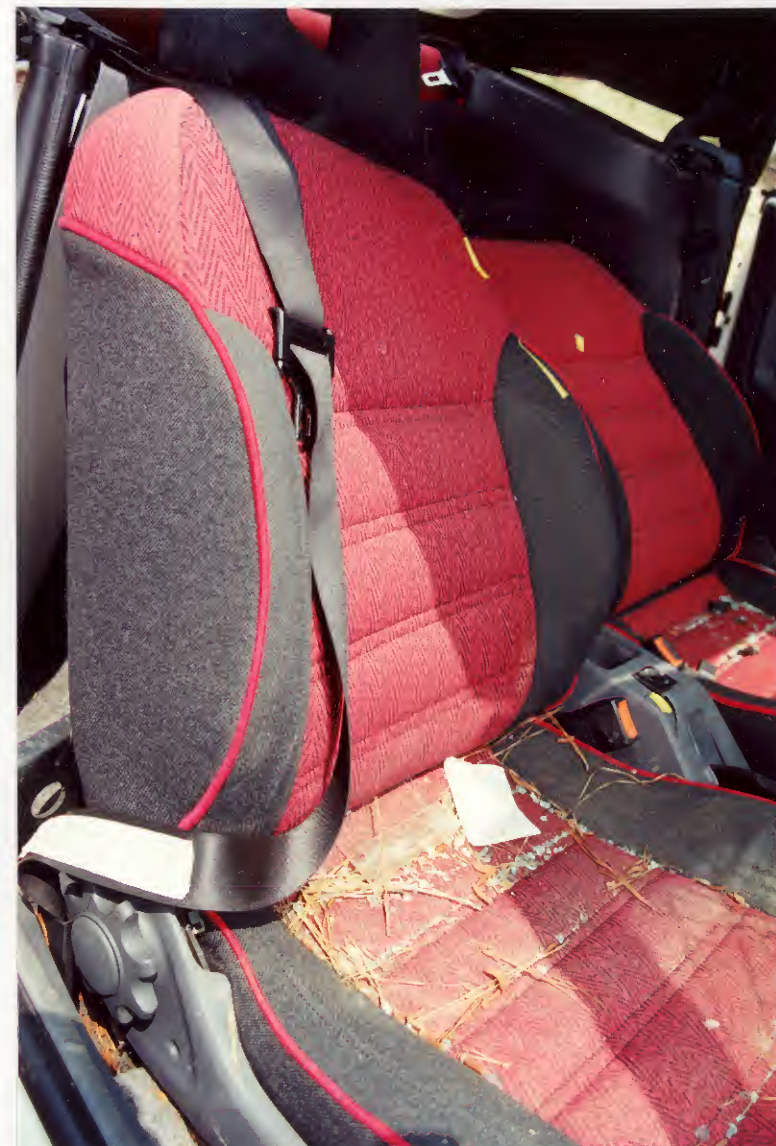
27-28. Front seats and seatbacks showing possible contacts and obvious contact to console.

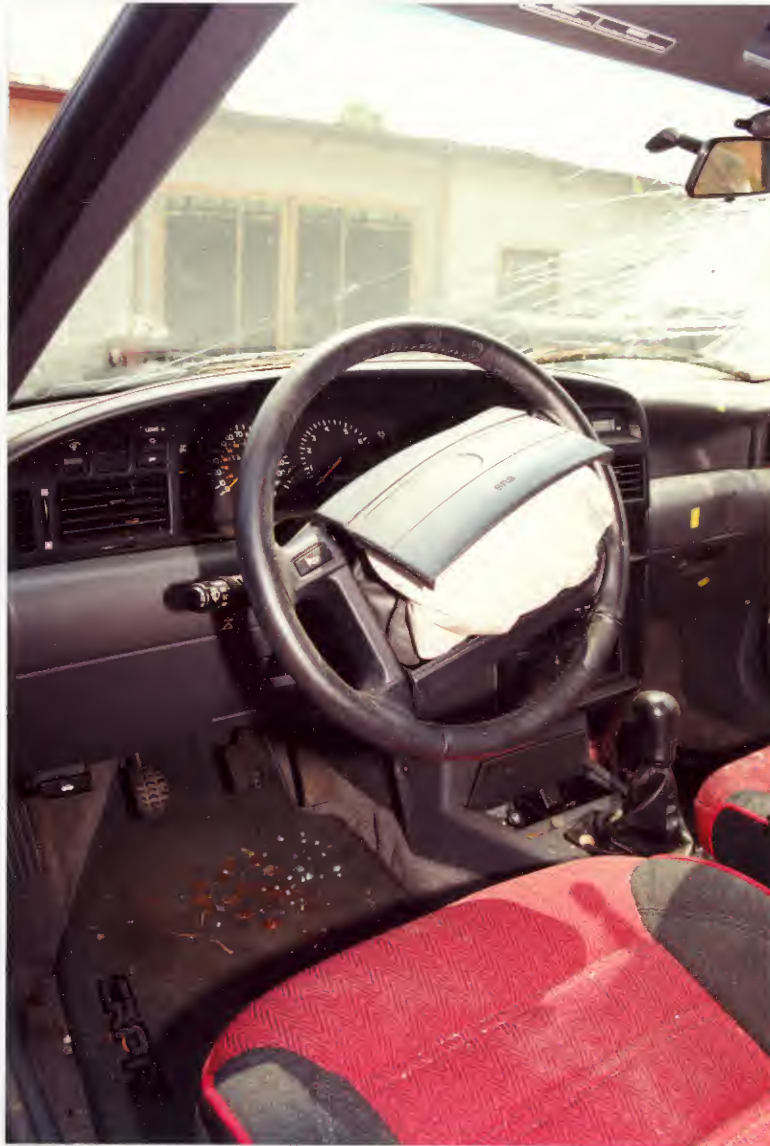
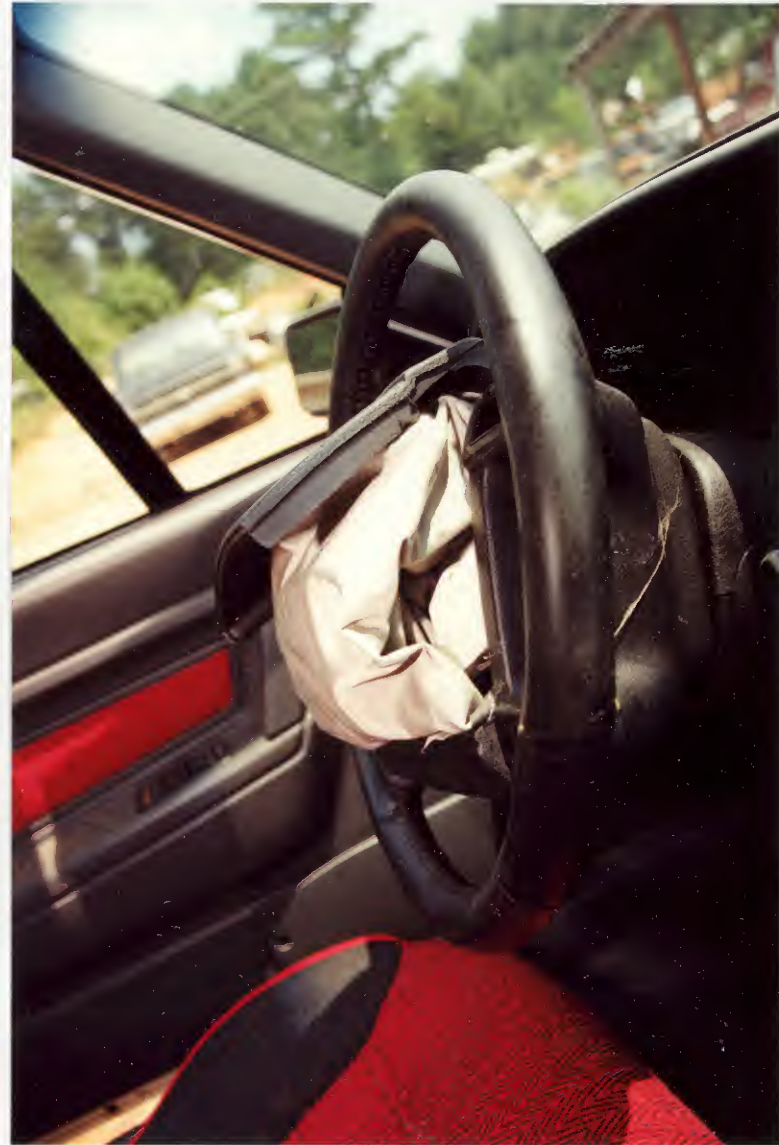
29-30. Views of airbag equipped steering wheel.
